Grafton Center Meetinghouse

Historic Building Assessment with Preservation Guidelines

May 2021

Christopher Thomas Ross, Architect
Enfield, NH

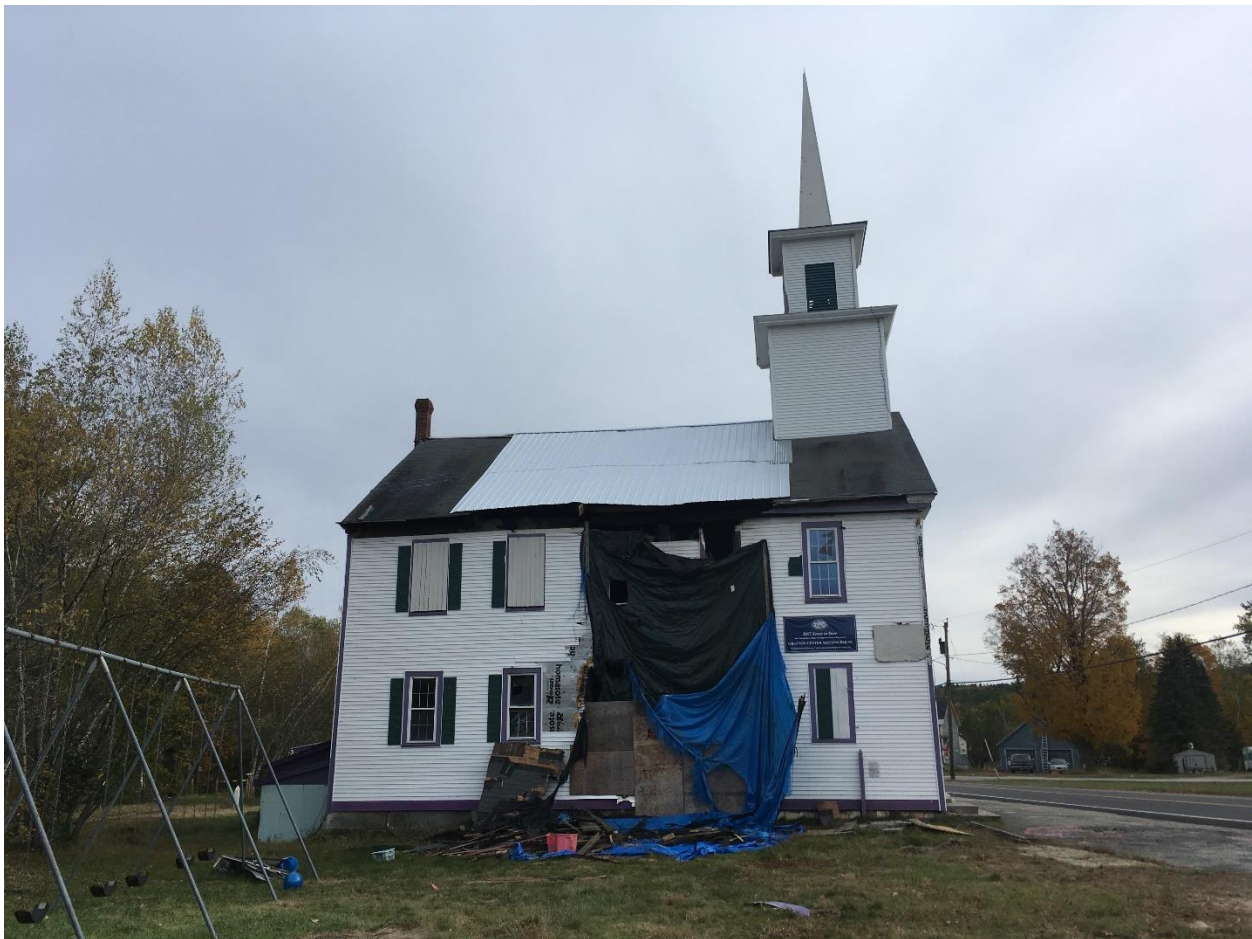
The north elevation, which was most heavily damaged by the 2016 fire, has five bays and is symmetrical. Physical evidence in the form of braces that survived the fire confirms that a pulpit window did exist in the central bay.

North elevation, showing the worst of the fire damage.

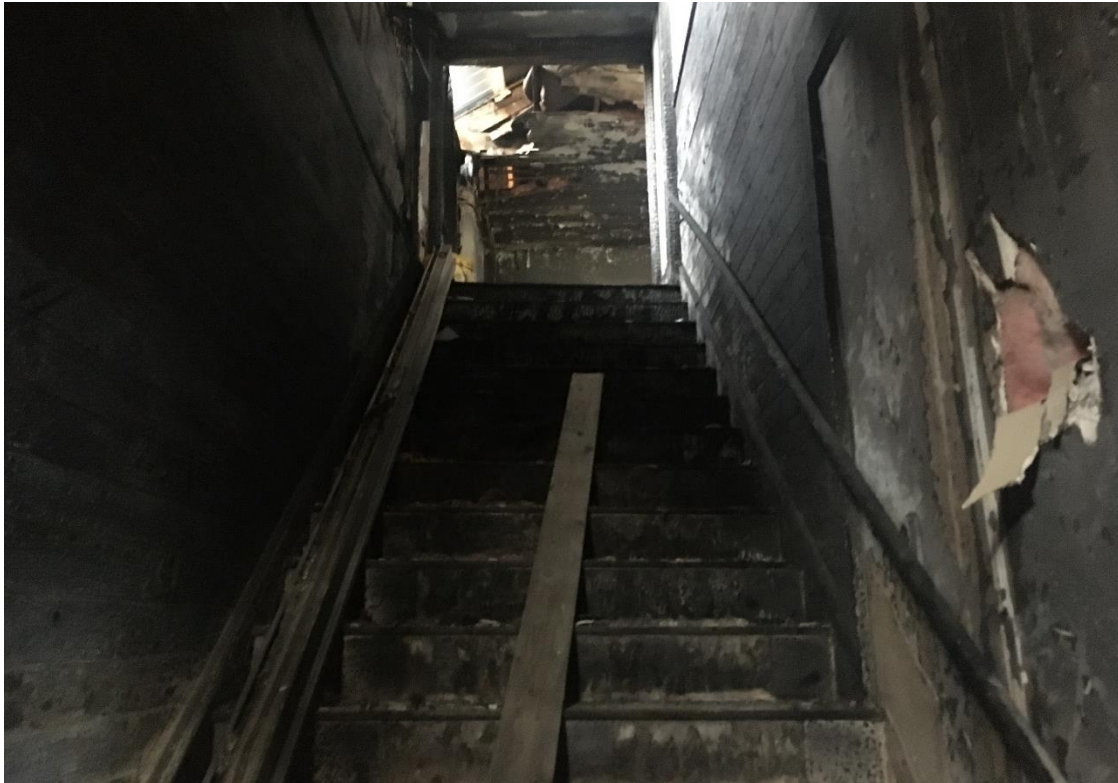
Above: the “coffin stairs” experienced heavy fire damage. Left: the SW spiral staircase survived the fire.

- carefully demolish wall and ceiling surfaces (tongue-and-groove boards) and remove layers of flooring, making sure to investigate for clues of building's evolution.
- remove "coffin" staircase, which is in very poor condition. Secondary egress will be provided in the rear addition, which is preferable from a code and fire safety perspective.
- remove interior walls, which show evidence of extreme decay at the base. Consult with an engineer to replace the wall with the replicas of the original gallery columns.
- install new hardwood flooring atop subfloor. Due to the expected high traffic count, recommended flooring would be white oak, in planks of 5-7".
- install insulation (fiberglass batting or rock wool) and modern MEP systems in walls before finishing with sheetrock or plaster.

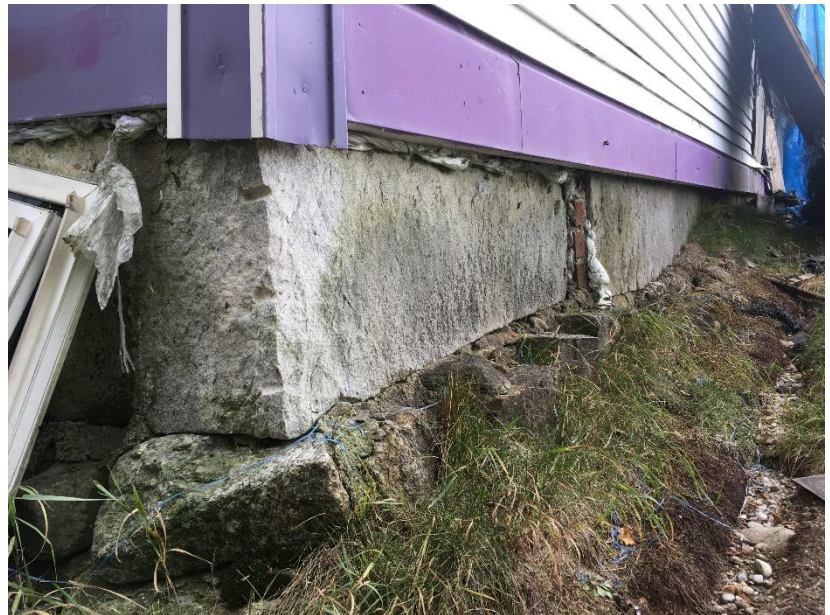
Condition. The foundation is constructed of rubble field stone and capped with split granite capstones. The basement is a crawlspace of maybe 3' maximum clearance. It is filled with fiberglass insulation, haphazardly applied in between the joists, and forced hot air ducts. The floor is dirt. Water infiltration exacerbated fungal growth and several joists have slipped from their pockets, causing major settling in the first floor.

Condition of granite foundation at the NE corner.

Treatment. After building is structurally sound, lift building and dig out the foundation to full 8' height. Pour frost-proof concrete walls and floor, keeping and re-installing granite capstones. The building may benefit from being raised 6" or so to lift the sills further away from Route 4 (which will continue to rise with shim coats). This new level can be concealed with proper grading.

Replace sills, joists, and beams as necessary; sistering where possible. Consult with an engineer about footings and posts in the basement that will support the building.

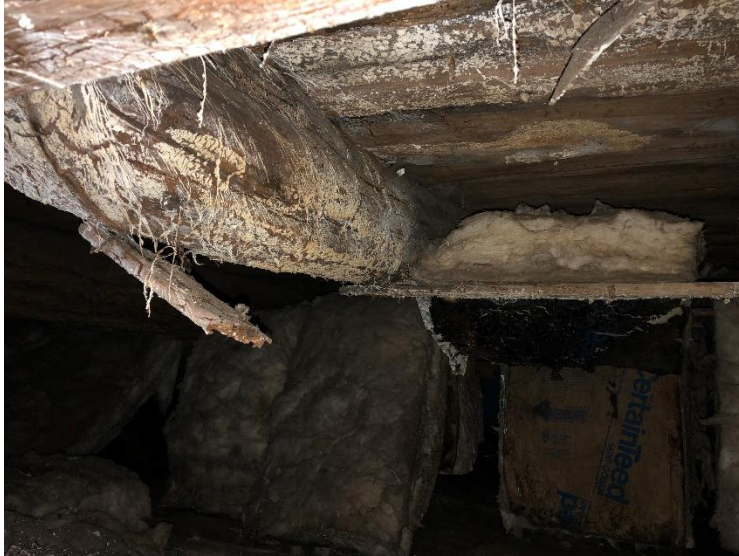
Undercarriage, showing fiberglass batting and mold growth.

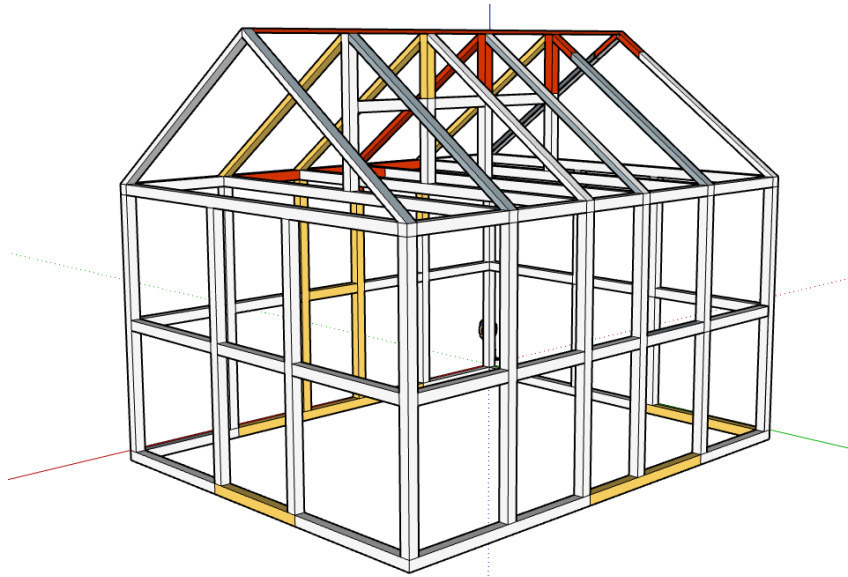
The following illustrations show which timbers will need replacement (red) vs. repair or further investigation (yellow).

Meetinghouse frame (without steeple), looking NE from SW corner. (Note: purlins and studs not included.)

It can be expected that upwards of half the floor joists and roof purlins will need to be replaced due to fire damage and rot, as well as the entire ridge pole. Larger timbers will require entire replacement, sistering, and/or splicing. An experienced timber framer should consult with an engineer to develop a specific plan for how best to address weakened members and how to join the historic and new timbers.

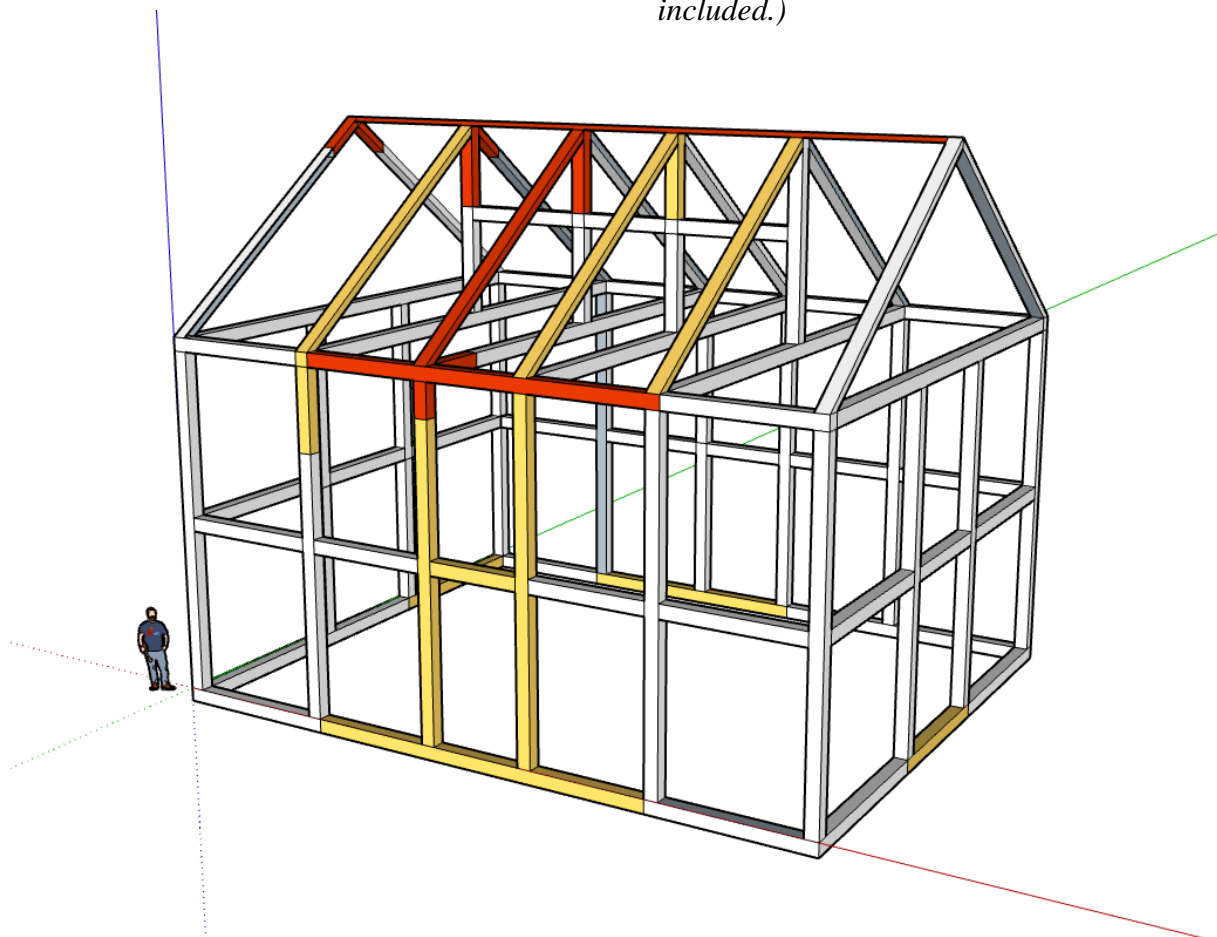
North side of the Meetinghouse, showing concentration of needed repairs and replacements.

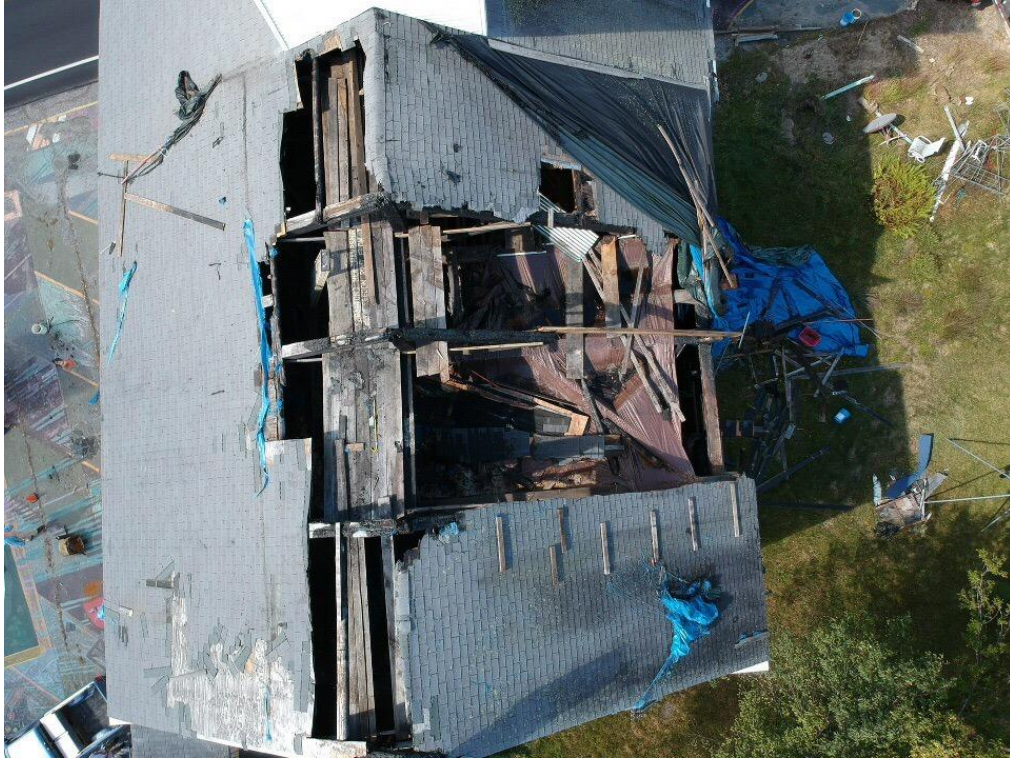
Aerial view of the roof with portions of the roofing removed. The middle bent is without a rafter, and is temporarily connected to the top plate with dimensional lumber.

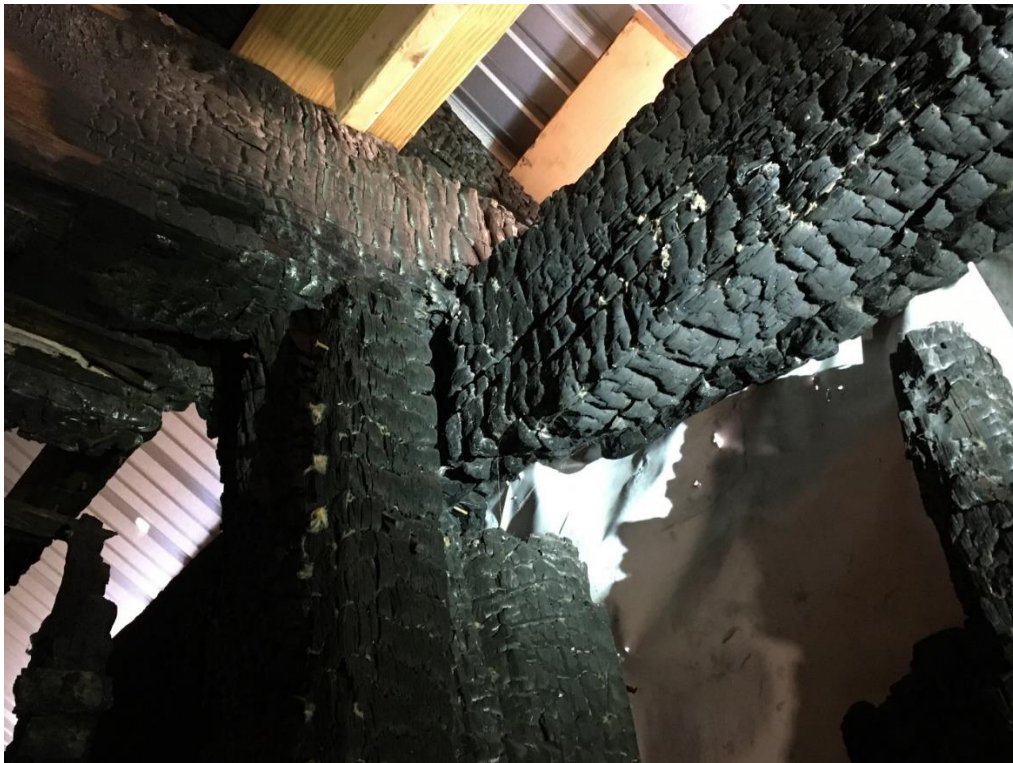
Close up of a joint at a central bent, showing the extent of charring and weakened joinery.

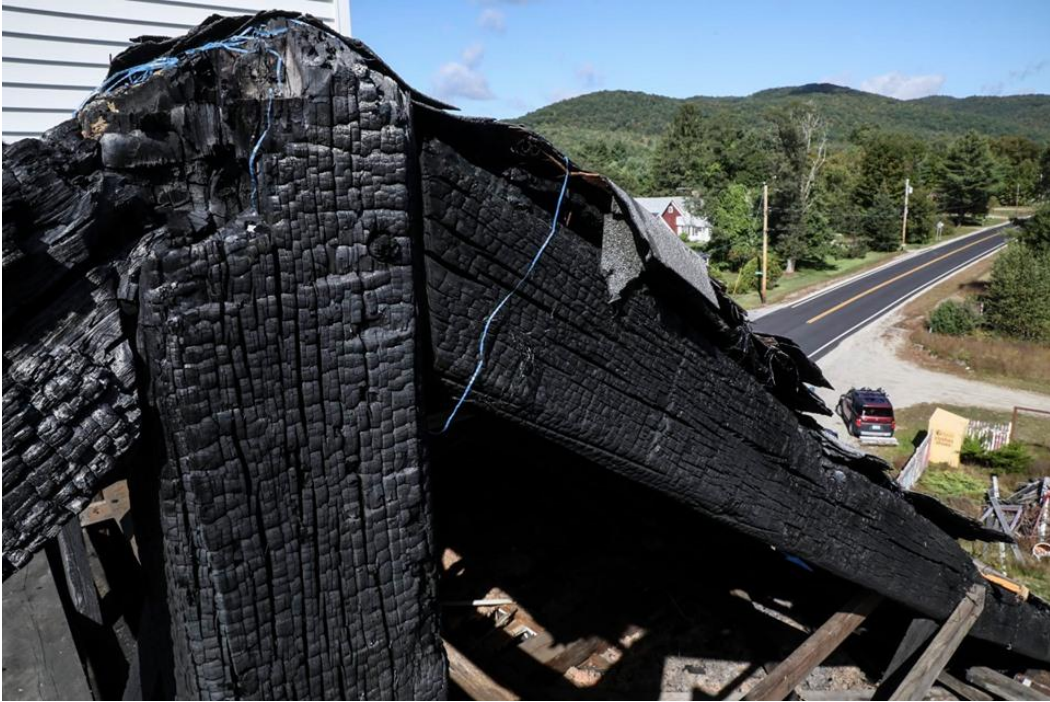
Close up of charring at a king post and rafter joint.

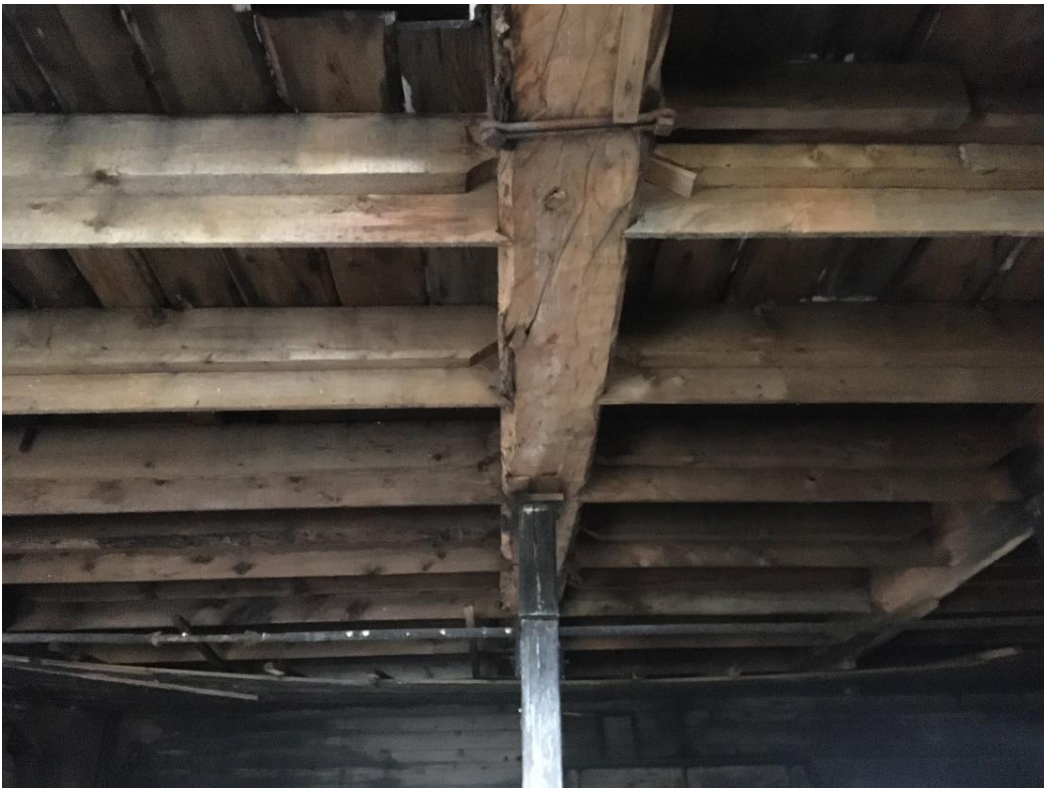
The second story floor system appears to be in good shape and should continue to dry out over the winter.

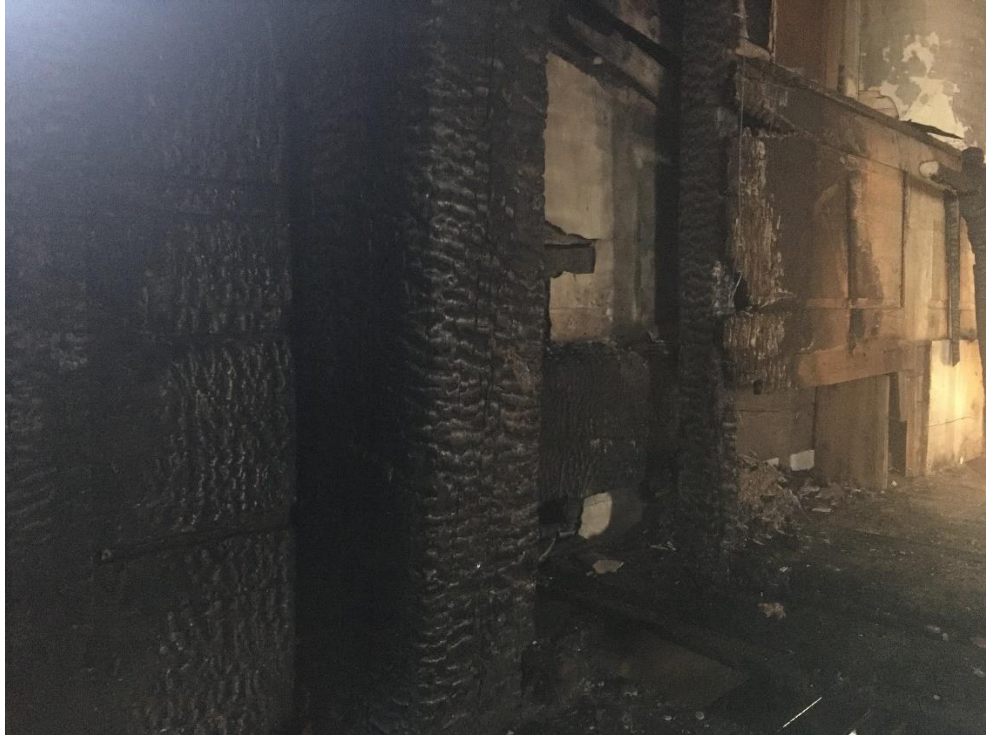
The north side's central bents' posts sustained the most fire damage and will likely need to be fully replaced if the removed charring reveals too much structural damage.

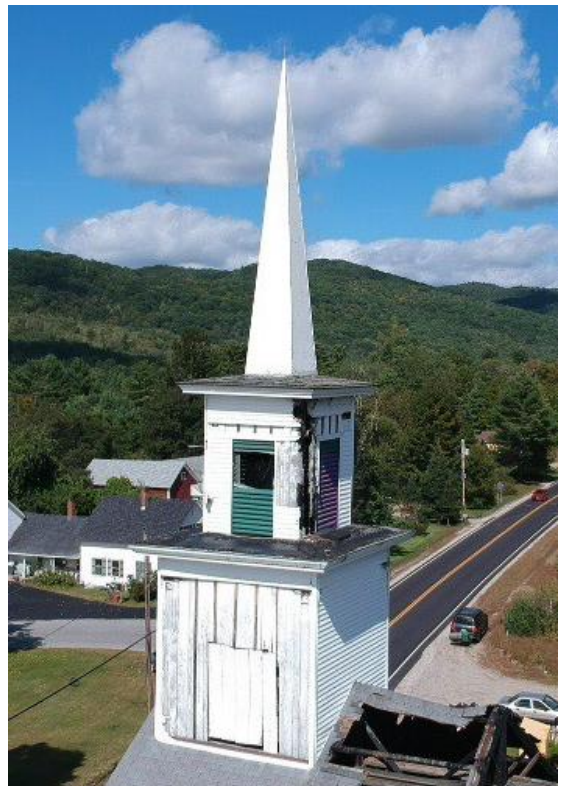
Bell Tower Condition. The bell tower is in decent shape, structurally, but needs new flush boards on the southern side and new trim on second tier at the SE

corner. No spire existed atop the tiered bell tower until 1983, when the congregation fundraised and installed one.

- fiberglass spire should be removed as it is not historic.
- two tiers' roofs should be stripped and re-roofed with either rubberized membrane or durable panelized metal (such as copper or lead-coated copper).
- louvers to be repaired/replaced as necessary.
- remove vinyl siding and aluminum trim; inspect condition of wood clapboards and trim beneath. Repair or replace wood elements as needed.
- scrape and paint exterior surfaces.

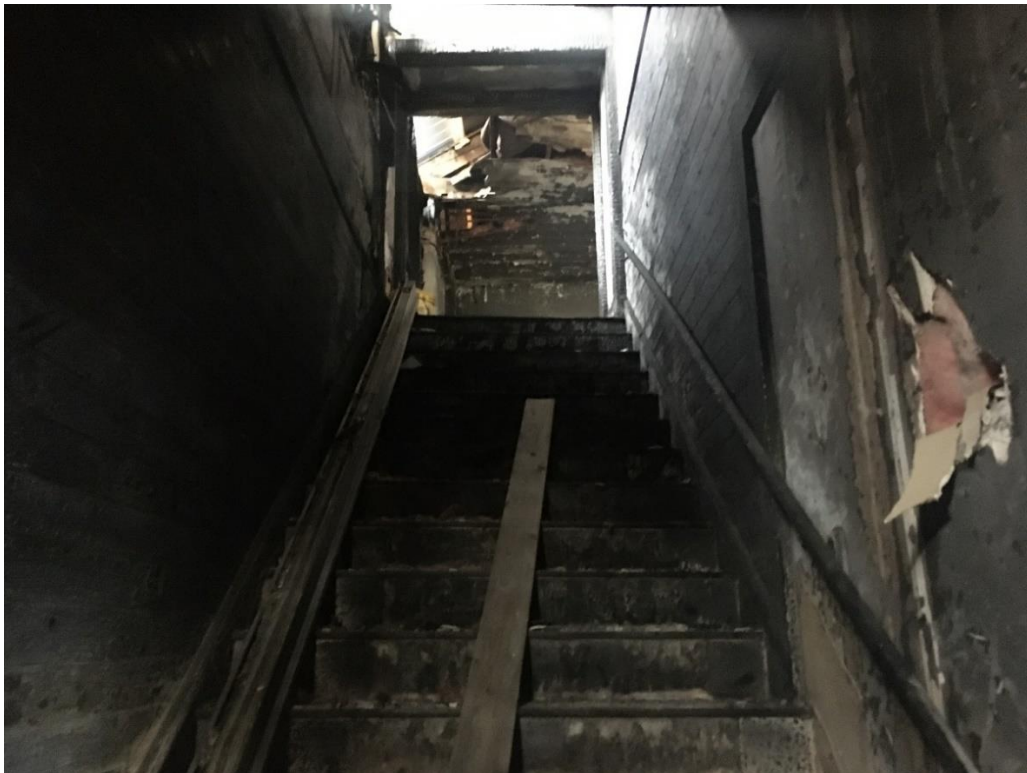
The “coffin stairwell” in the NW corner of the first floor, looking up toward sanctuary.

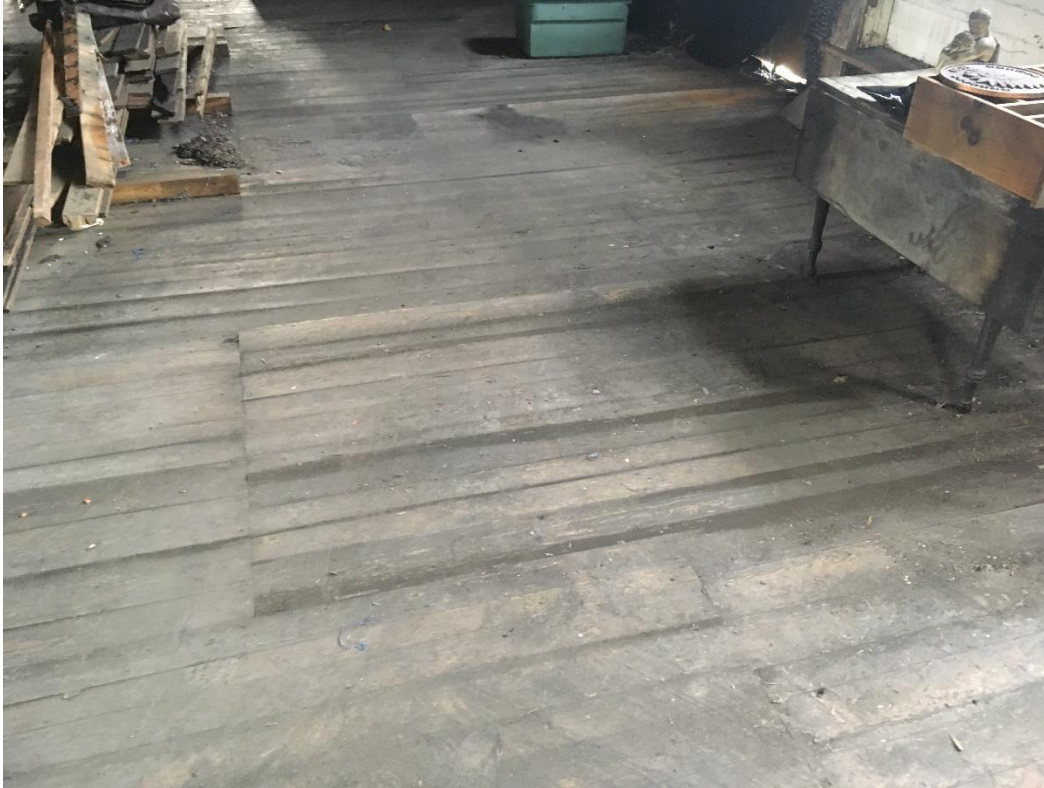
The floorboards on the first floor were heavily damaged by three years of elemental exposure.

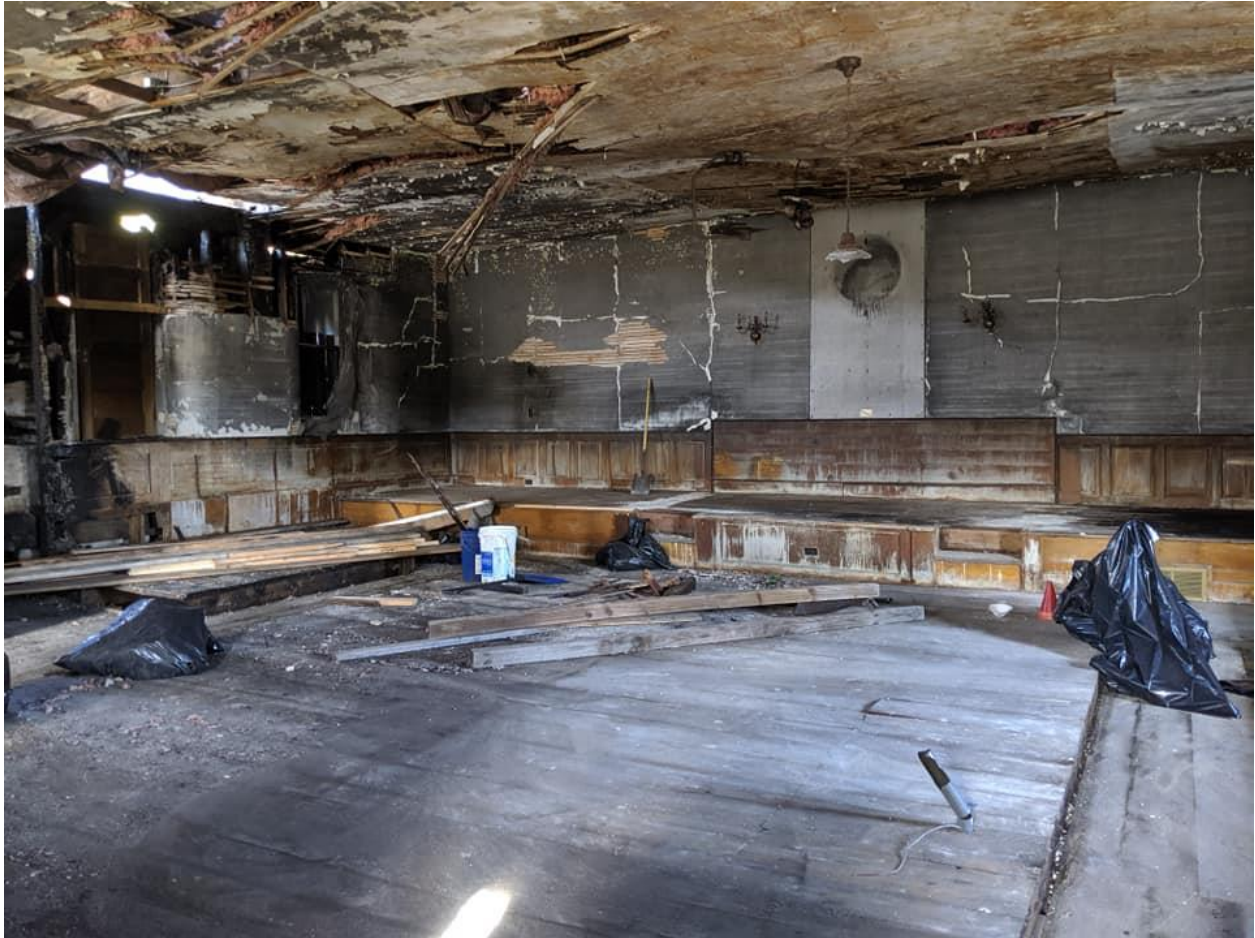
The north elevation is in the worst condition, with most of the historic fabric burned or compromised. The plaster ceiling and wood flooring are not salvageable after years of water damage. Fortunately, enough of the 18th and 19th century material exists to replicate paneling. The chestnut pews were documented and removed in preparation of the rehabilitation.

Interior of second floor looking east toward the altar platform.

- remove plaster ceiling (this will allow bottom cords of timber frame to dry out more completely).
- remove plaster and lath and damaged wainscot paneling on north wall in preparation of timber frame repairs.
- remove raised platforms where pews once stood and altar platform to create level flooring area; install hardwood flooring. Retain the choir loft platform. MVP could choose to demarcate where the raised platforms were with contrasting wood flooring.
- install insulation (fiberglass or rock wool batting) and modern MEP systems in walls and ceiling before finishing with plaster.
- recreate wainscot paneling and coved window openings where fire damaged the originals (and where the coffin stairwell interrupted the historic floor layout).

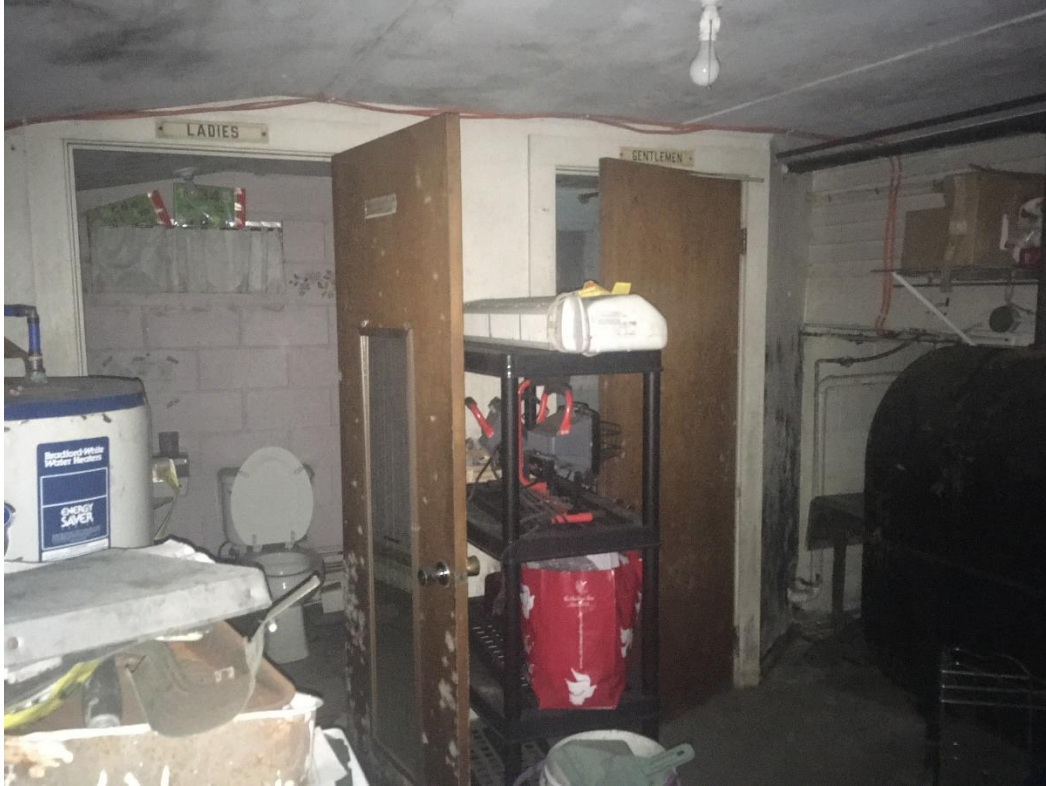
The current rear additions are inadequate for restrooms and egress. These 1940s subterranean additions of concrete blocks and shed roofs are perennially damp and flood in the springtime (and freeze with inches of ice in the winter).

Existing bathrooms.
