Grafton Center Meetinghouse

Historic Building Assessment with Preservation Guidelines

May 2021

Christopher Thomas Ross, Architect
Enfield, NH

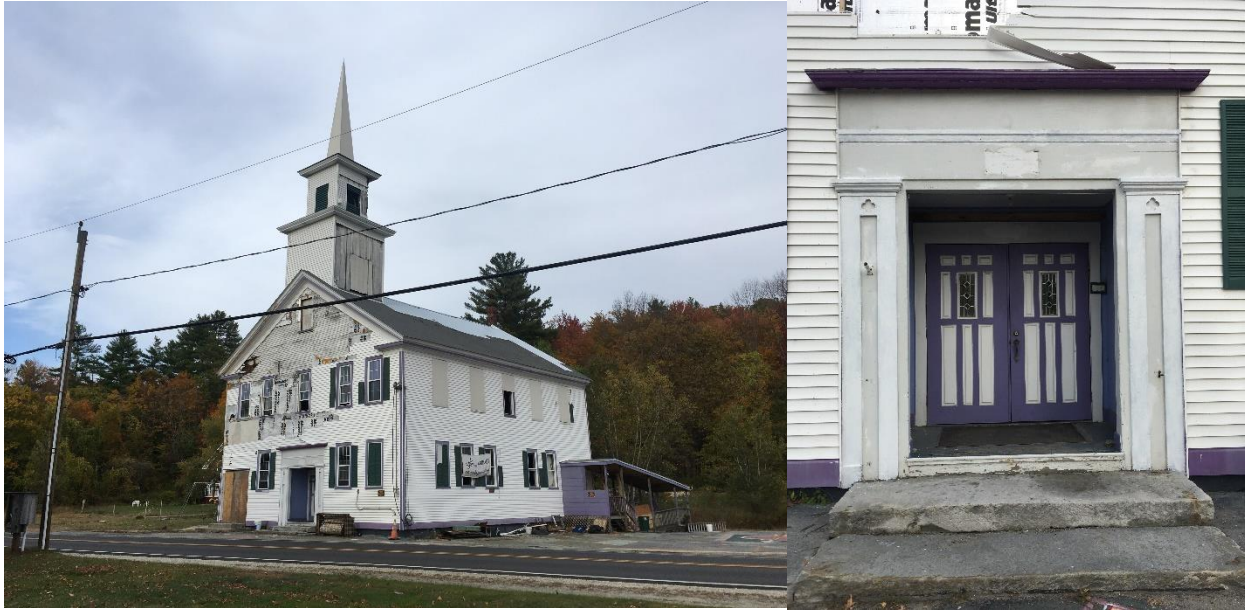
TODAY. The façade, or the west elevation, faces the common; it is divided into five bays, with a two-tiered steeple extending from the gabled front. Atop the bell tower steeple is a fiberglass spire added in 1983. The first floor includes a substantial central recessed entranceway whose vertical trim includes inset trefoil motifs, which are also replicated on the steeple’s corner boards (currently covered in vinyl). A secondary entranceway, on the northwest corner, dating to the 1940s, was an attempt to make the northwest stairwell more accessible to the handicapped and to ease the delivery of coffins. Both sets of doors are unoriginal.

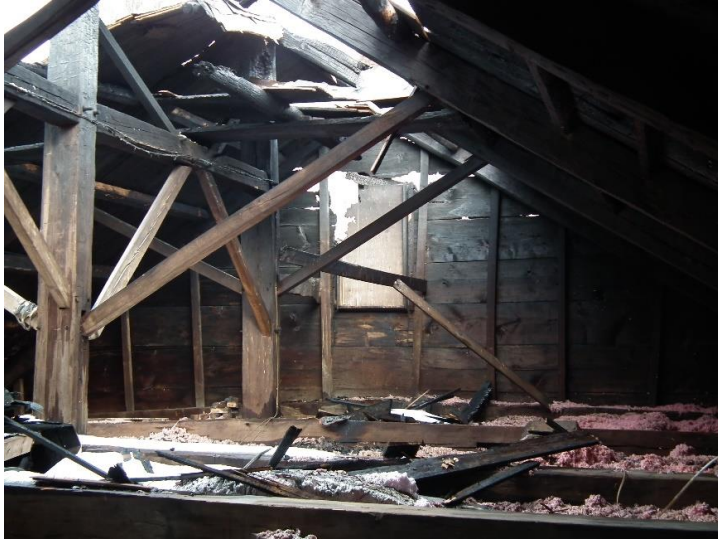
Attic, looking east.

The attic reveals a hefty king post truss frame, similar to Grafton's first meetinghouse – the North Meetinghouse. The bottom chords are slightly cambered – there is an 8" difference in the sanctuary's ceiling height between the plates and the king post. Unlike with many other clear span spaces, the Grafton Center Meetinghouse's bottom chords have not slipped from the king posts. It is not clear *how* the king posts are secured to these bottom chords.

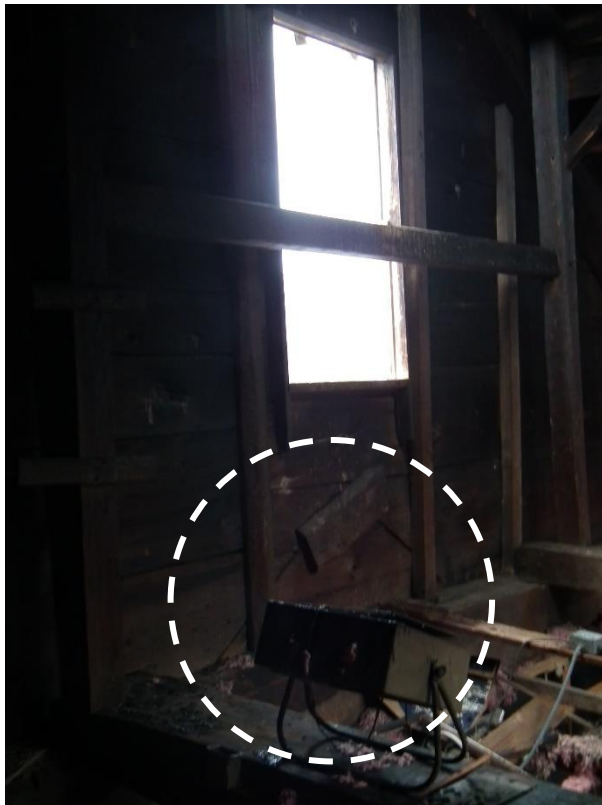
West gable end, showing roofline of the original porch below the window opening.

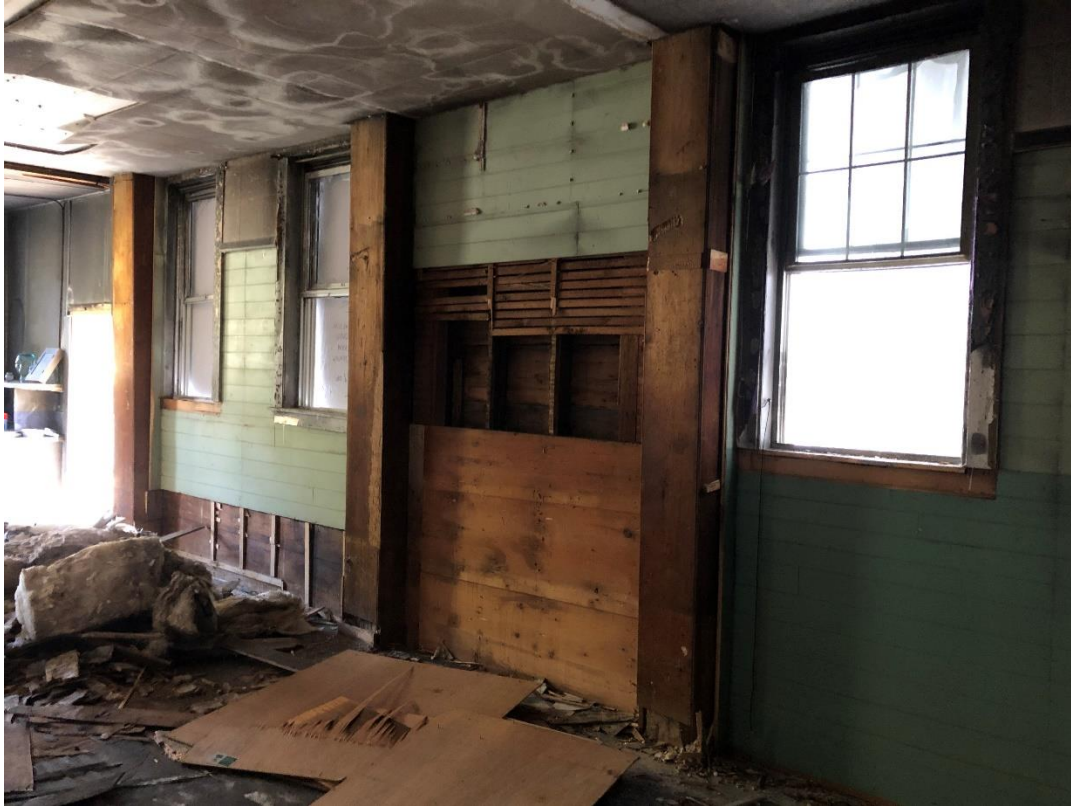
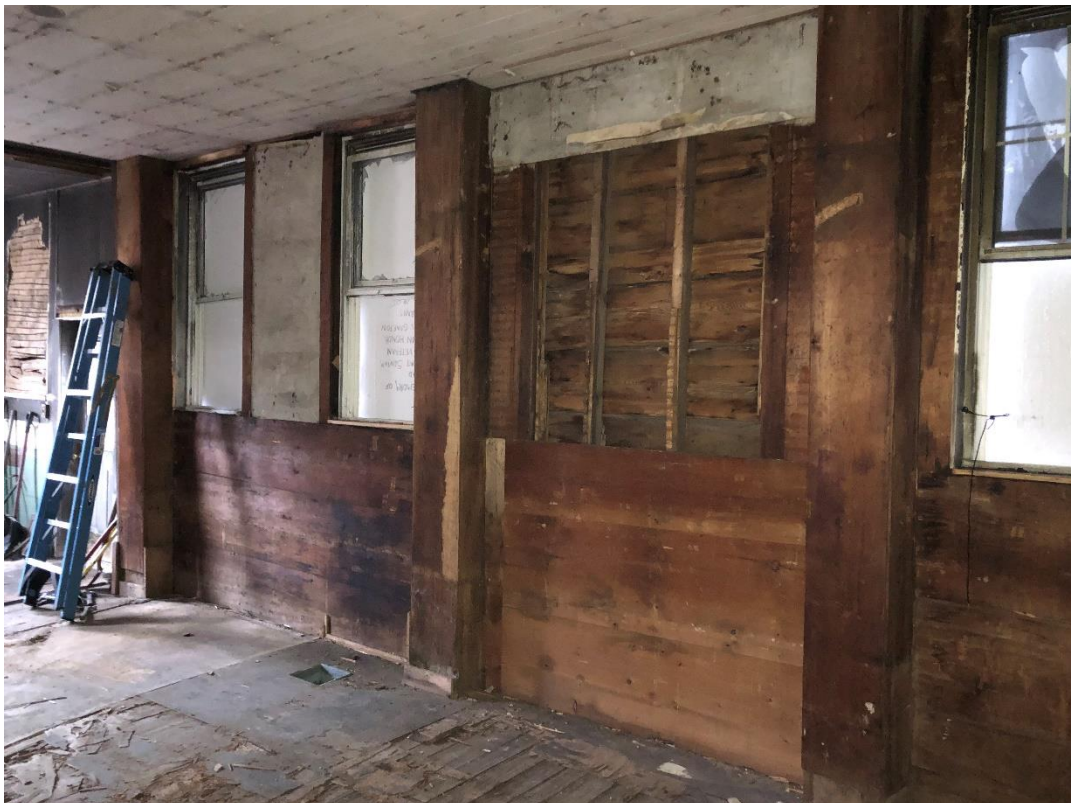
Interior of first floor during (above) and after (below) selective demolition, looking south where former central entrance was. The green beadboard was applied atop the original plaster and wainscot.

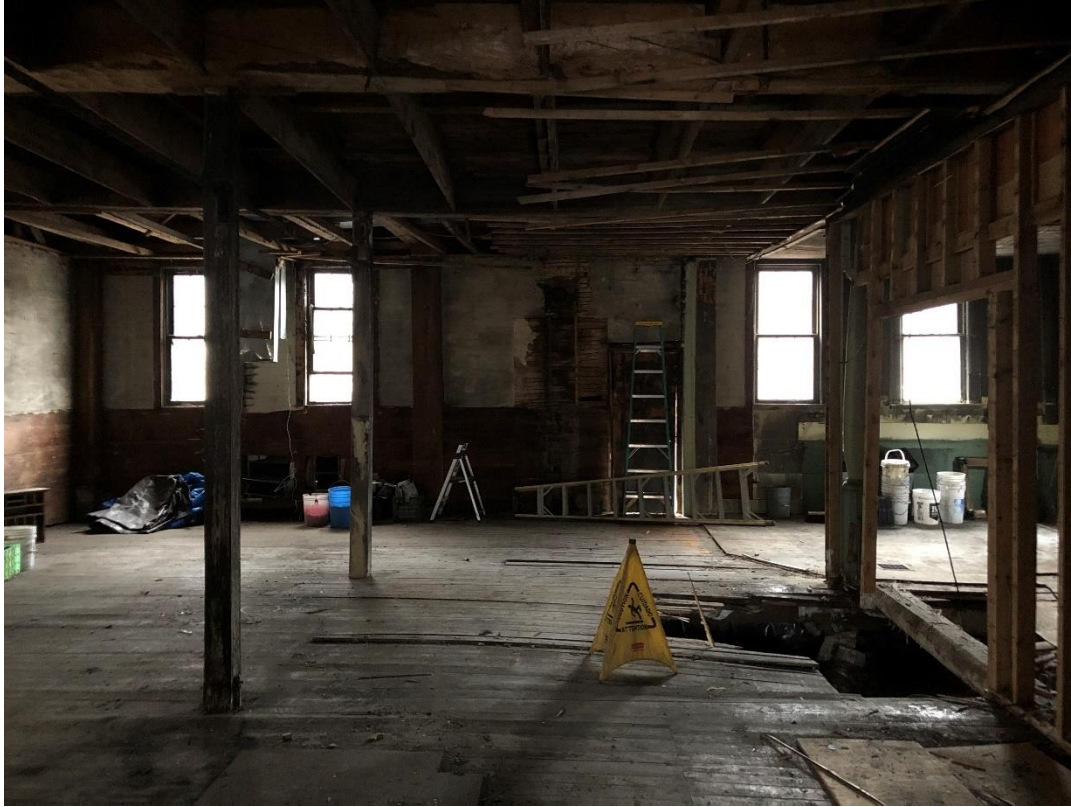
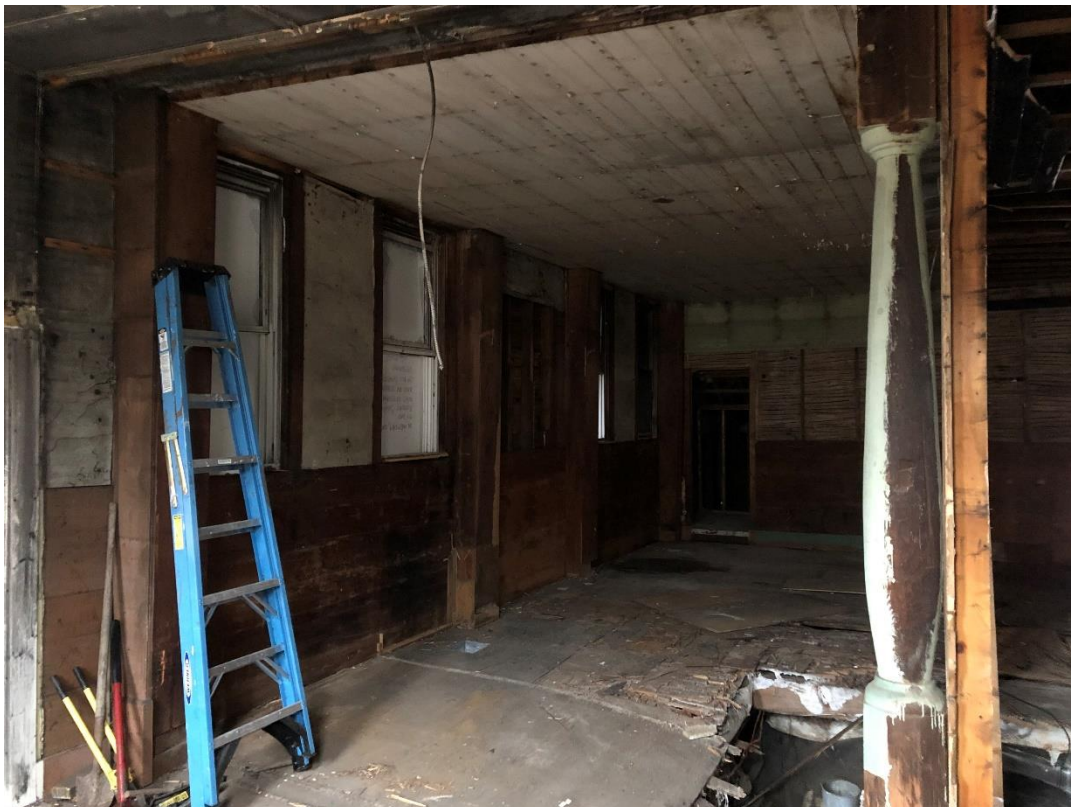
Above: first floor, looking east. Below: first floor, looking SW (original gallery column on the right).

Original material on the first floor includes the wide board wainscot paneling below the window sills, the window trim, a gallery column, and the plaster. This material is in fair condition, considering its age and the building's fire and water damage. The wainscot and enclosures for the posts are finished with beaded edges.

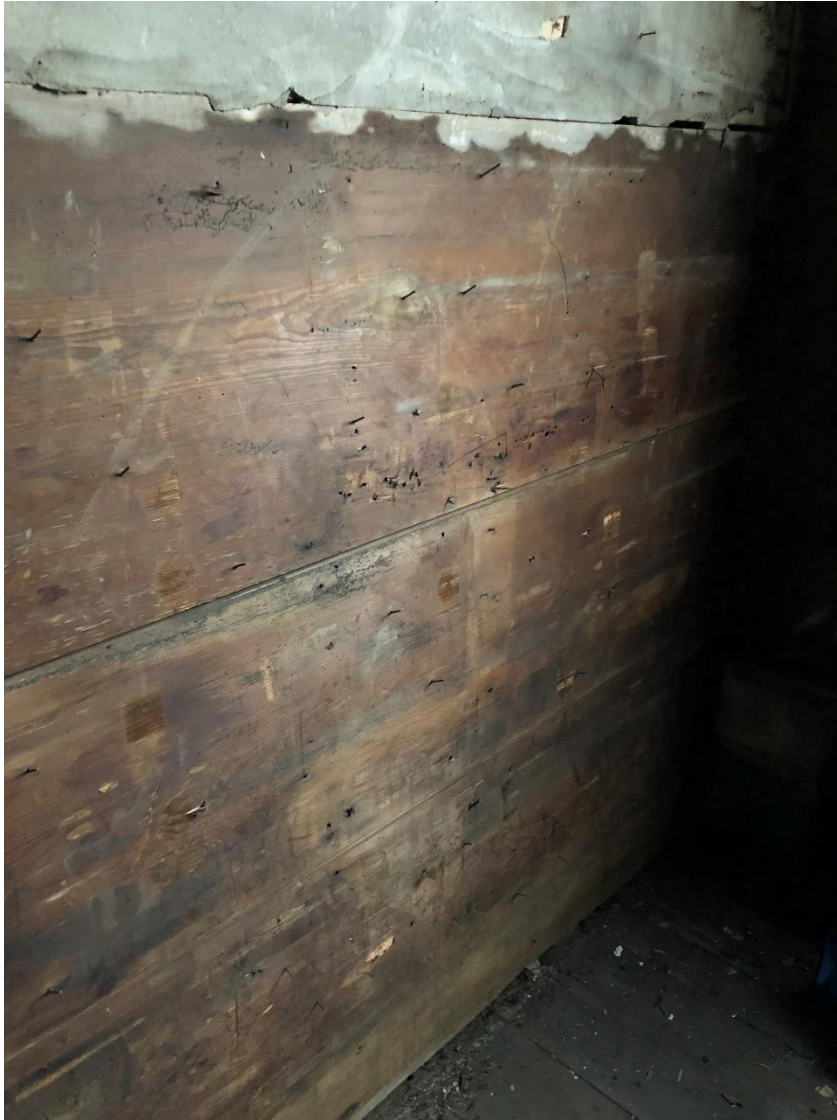
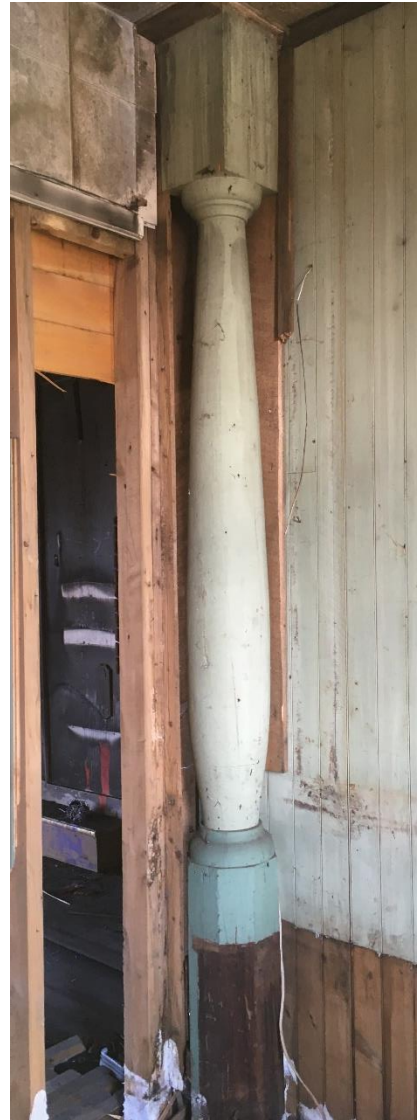
Left: Close-up of the wainscot boards with the beaded edge. Right: 1797 gallery column.

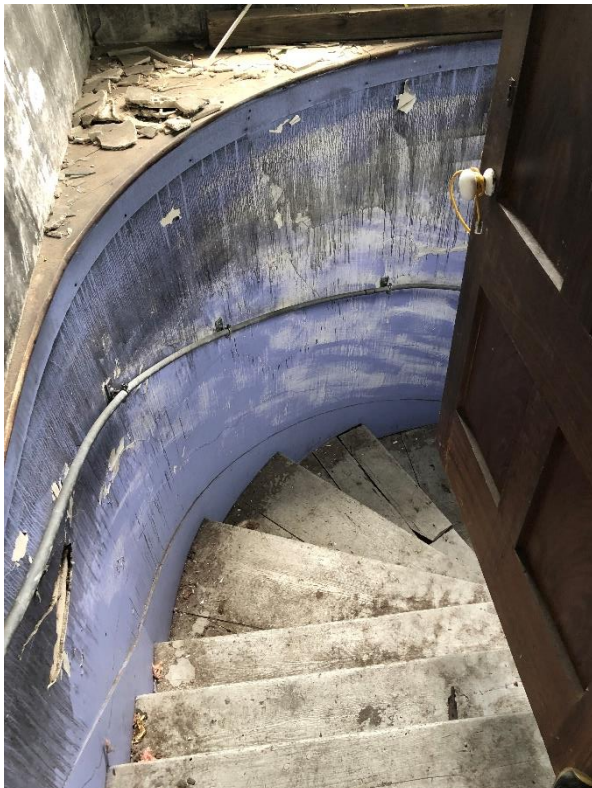
Above: the “coffin stairs” experienced heavy fire damage. Left: the SW spiral staircase survived the fire.

- carefully demolish wall and ceiling surfaces (tongue-and-groove boards) and remove layers of flooring, making sure to investigate for clues of building's evolution.
- remove "coffin" staircase, which is in very poor condition. Secondary egress will be provided in the rear addition, which is preferable from a code and fire safety perspective.
- remove interior walls, which show evidence of extreme decay at the base. Consult with an engineer to replace the wall with the replicas of the original gallery columns.
- install new hardwood flooring atop subfloor. Due to the expected high traffic count, recommended flooring would be white oak, in planks of 5-7".
- install insulation (fiberglass batting or rock wool) and modern MEP systems in walls before finishing with sheetrock or plaster.

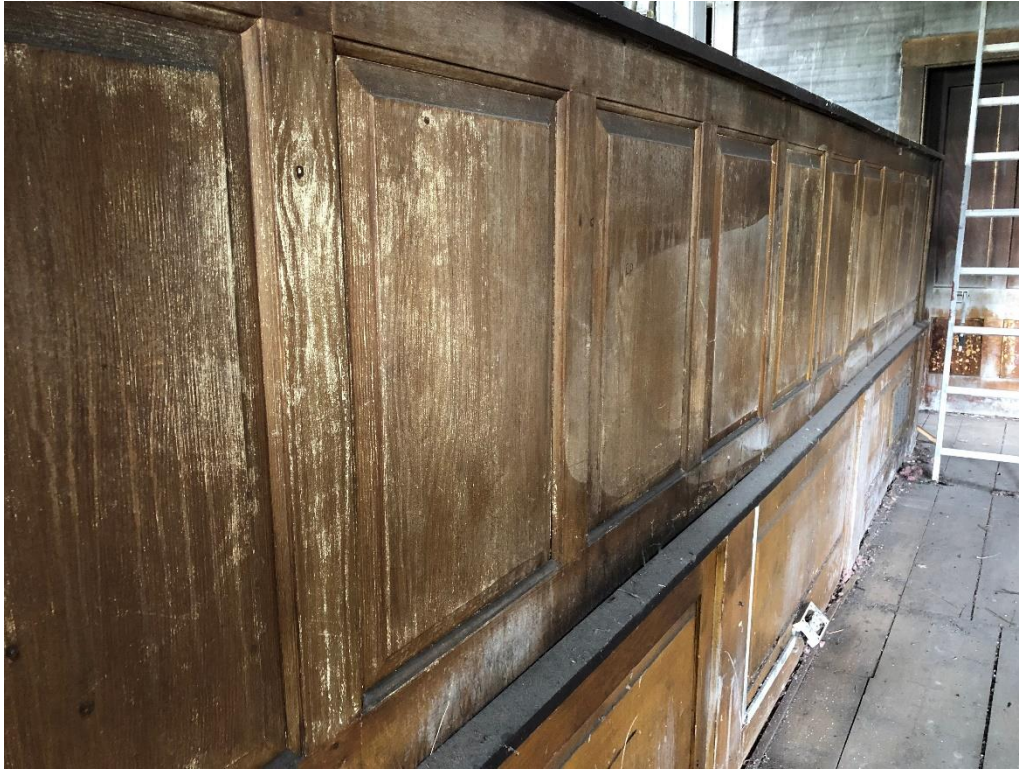
Paneling in the sanctuary, recycled from the 18th c. gallery breast work.

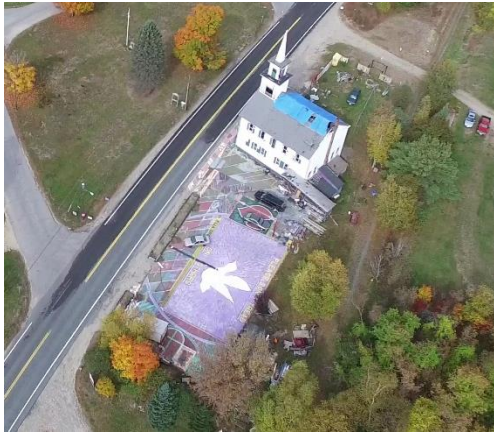
The parking lot is currently painted and has substantial cracking. The pavement extends to the foundation along the south and west elevations.

-When repaving, avoid paving right up to the building's foundation.

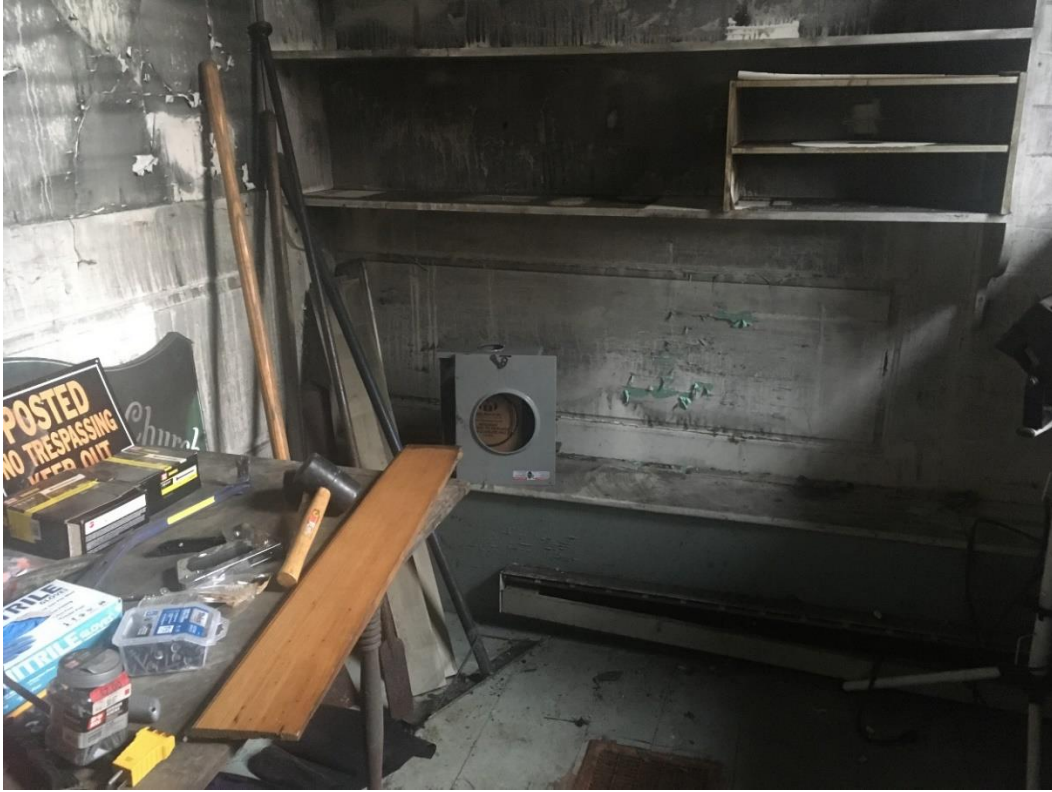
The first floor space was altered in the 1940s to include smaller rooms, tongue-and-groove ceiling and walls, and a new stairwell in the NW corner. The finishes on the first floor were most heavily damaged by fire and smoke. 18th and/or 19th century material remains beneath these later finishes, including some paneling, wainscot, plaster, and window casing – see below.

Paneling in the stair landing room at the SW corner of the first floor, showing paneling.

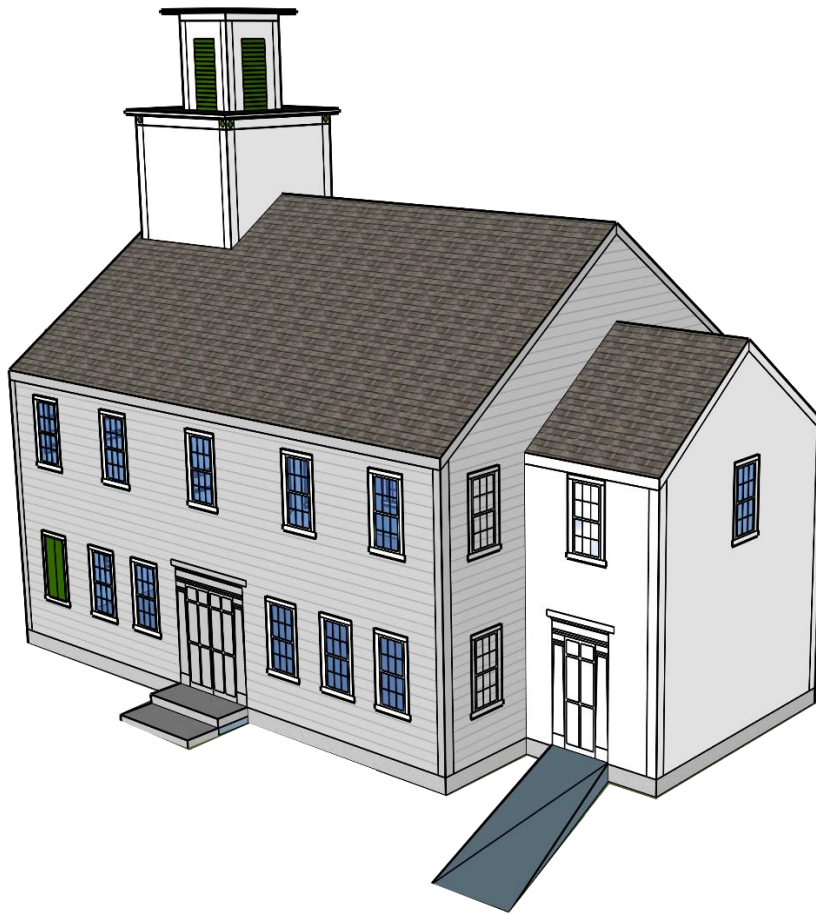
A rendering of what a rear addition could look like, pending property line review.

Option 2) Design a rear addition to accommodate some, if not all, of the programmatic needs (stairwell, restrooms, elevator, etc.). This new addition should be compatible, subservient, discernible, and severable from the historic building. See Preservation Brief 14 for further guidance.

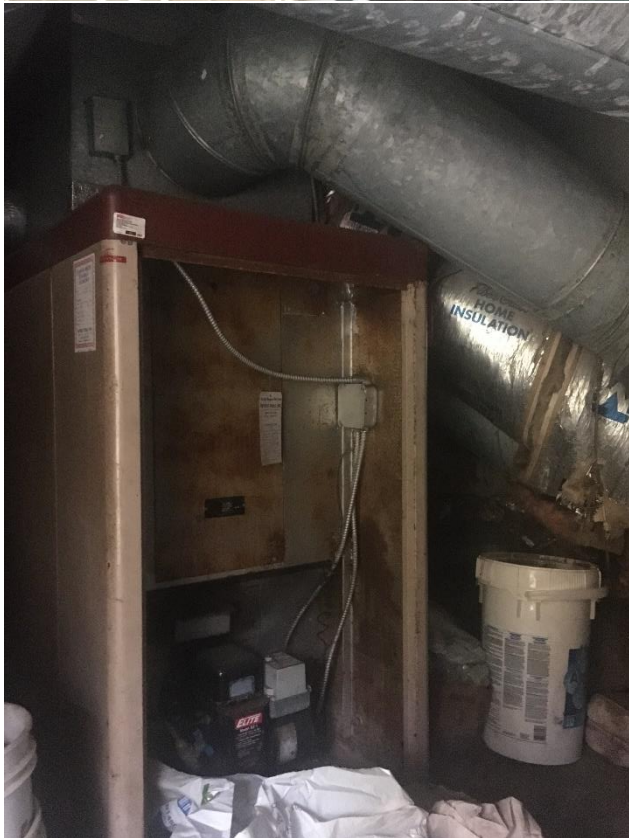
The building's MEP systems should all be replaced, including electrical, plumbing, heating/cooling, and septic. These systems were all damaged in the fire, were done haphazardly when installed, and – in the case of the septic system – are not up to modern standards. This is especially true if the new use of the Meetinghouse is to be a general store/marketplace.

Existing furnace.
